Following on from my site survey of \_\_\_\_\_ I can make the following comments;

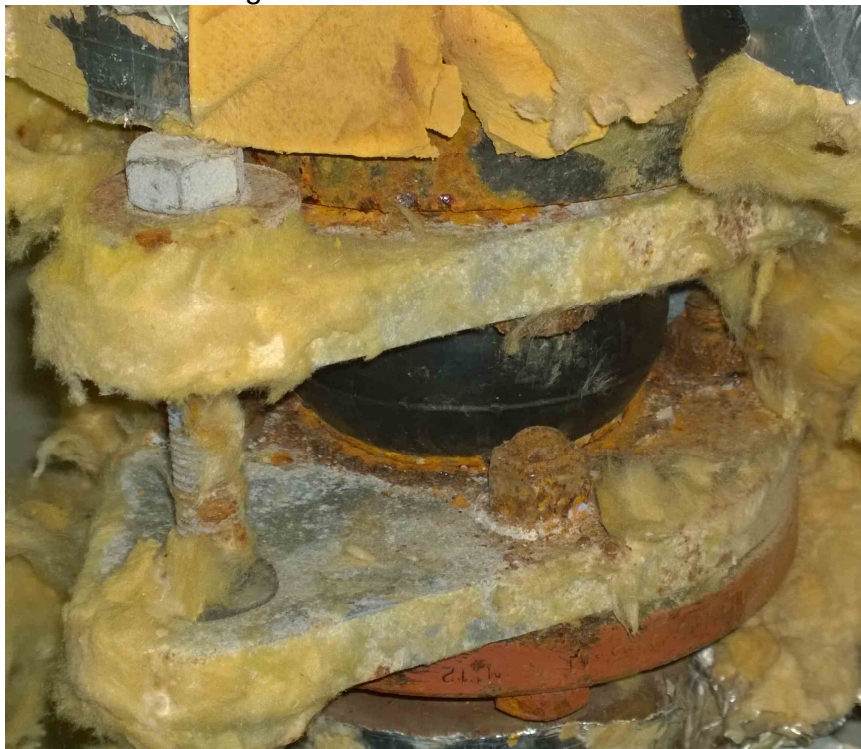
**Plantroom 14, Pump Reference: Maternity Pully**

2 x 65mm Stourflex type JP02, correctly installed although slightly over compressed. It appears they may have been a leak at some point as the flanges are corroded. I would recommend these units are changed.

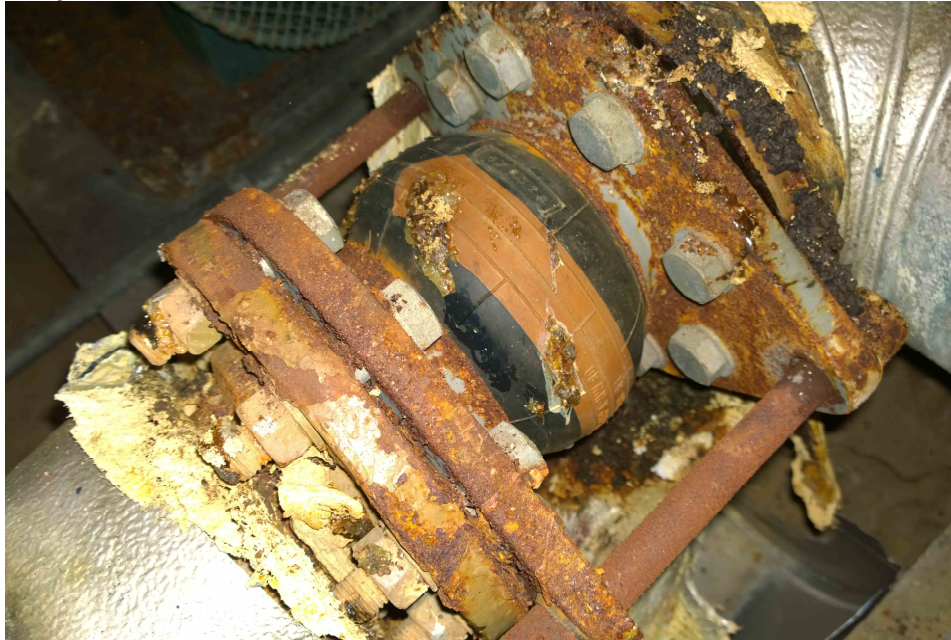
**Plantroom 14, Pump Reference: Maternity CHW 1**

2 x 80mm Engineering Appliances EPDM tied PN16, correctly installed, in very poor condition with cracks visible on the rubber and heavily corroded flanges, it also looks like some kind of sap or sticky substance has been dropped on the rubber over the years which may have further damaged the rubber. I would recommend these units are changed as a matter of urgency.

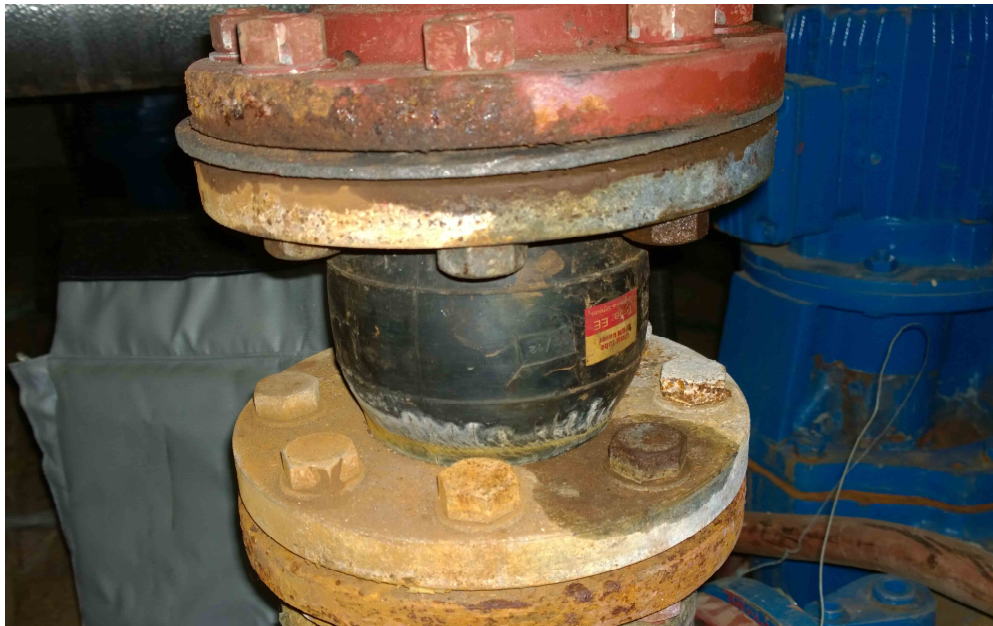
**Plantroom ZPL8, Pump Reference: South Podium**

2 x 80mm Stourflex type JP01 EPDM untied PN16, in-correctly installed by use of gaskets in-between rubber bellows and mating flanges, use of gaskets prevents a true seal being made between the rubber and the mating flange. In poor condition with cracks visible on the rubber. Due to the cracks in the rubber these units & the leak these should be replaced as a matter of urgency.

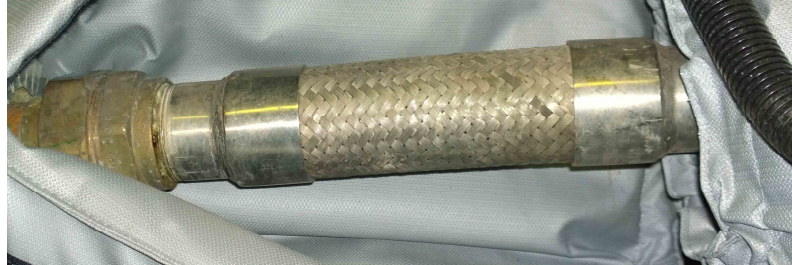
**Plantroom ZPL8, Pump Reference: A&E HWS**

2 x stainless steel braided pump connectors, 40mm Stourflex type JP20BS screwed male, correctly installed, length within tolerance, no need to replace currently.

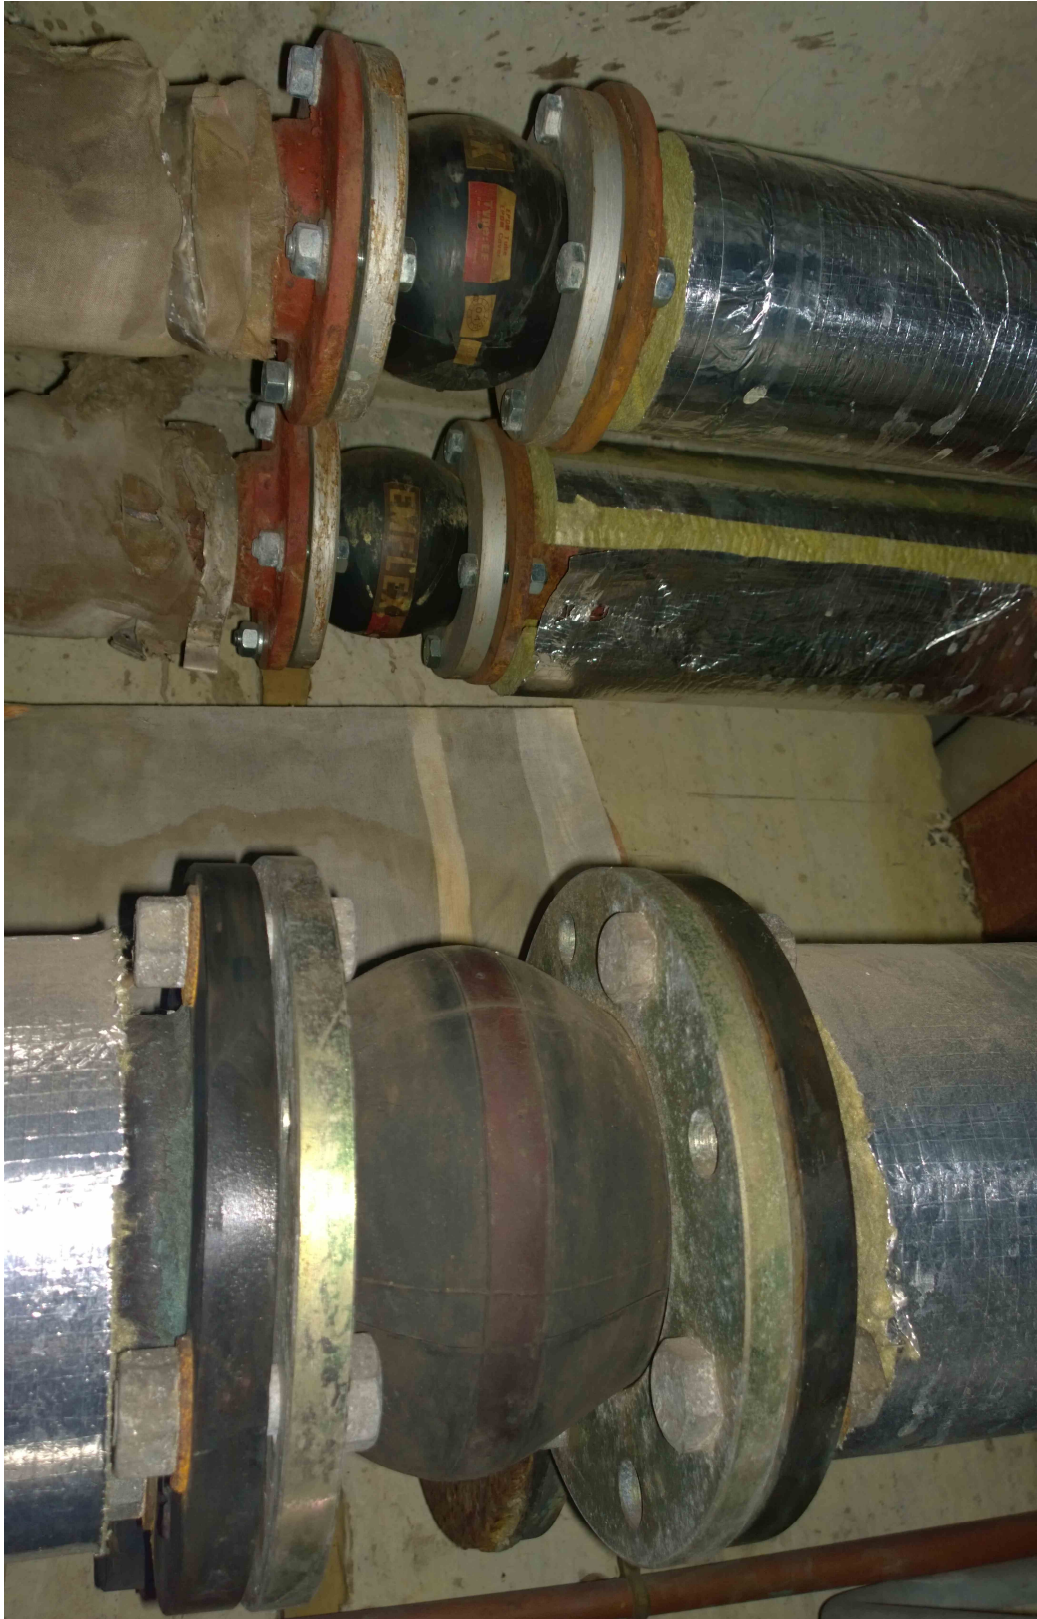
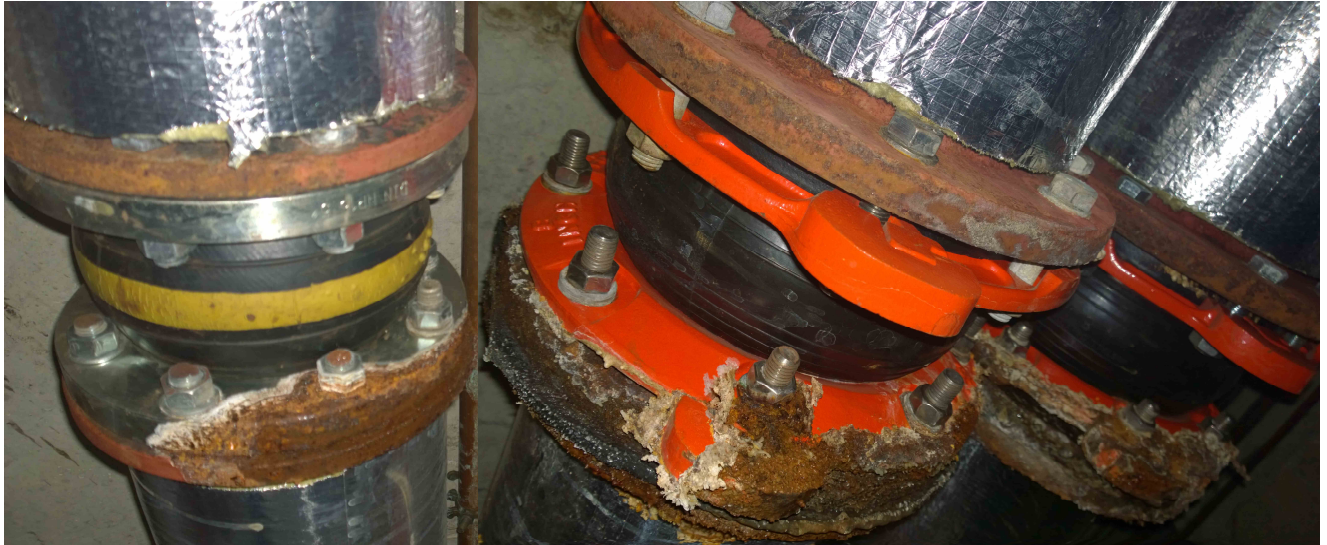
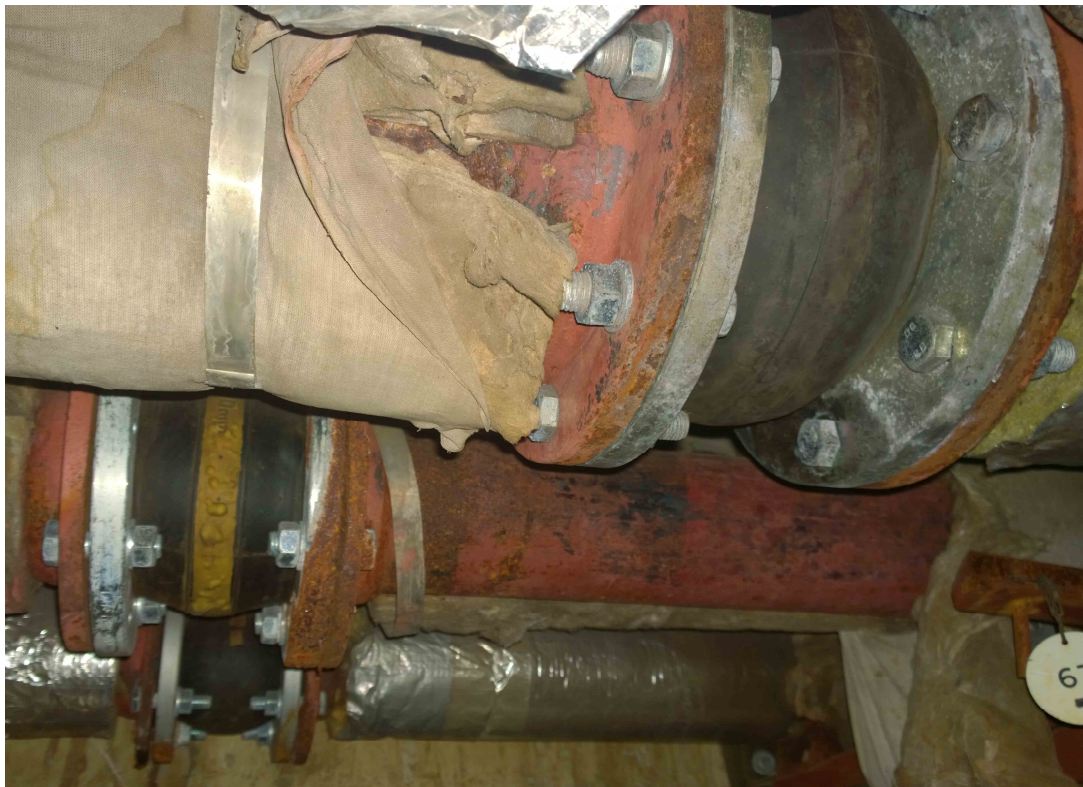
**Plantroom East West Duct ADI ZP08**

7 x Rubber bellows although there are also stool pieces that may indicate where failed bellows have been removed and not replaced. The location of these bellows is highly unusual as they are both sides of a 90° corner in the same pipes, I do not know if they were originally installed in a misguided attempt to deal with thermal expansion, or if they are there to prevent noise & vibration travelling along the pipe and potentially into a sensitive area of the hospital, indeed vibration could be felt in the pipes, brackets and supports as we stood there. All of the bellows are in a very poor condition and need either removing (if they are

deemed surplus to requirements) or replacing as a matter of urgency. This is because several of them are already leaking, some are starting to bubble under the skin of the bellows and some of them are extremely hard and brittle. There is a variety of bellows:

1 x 200mm EPDM Untied PN10 x 115mm Long on CT Heating. (This item is leaking badly as the 80mm rubber bellow has been installed into a 70mm pipe).

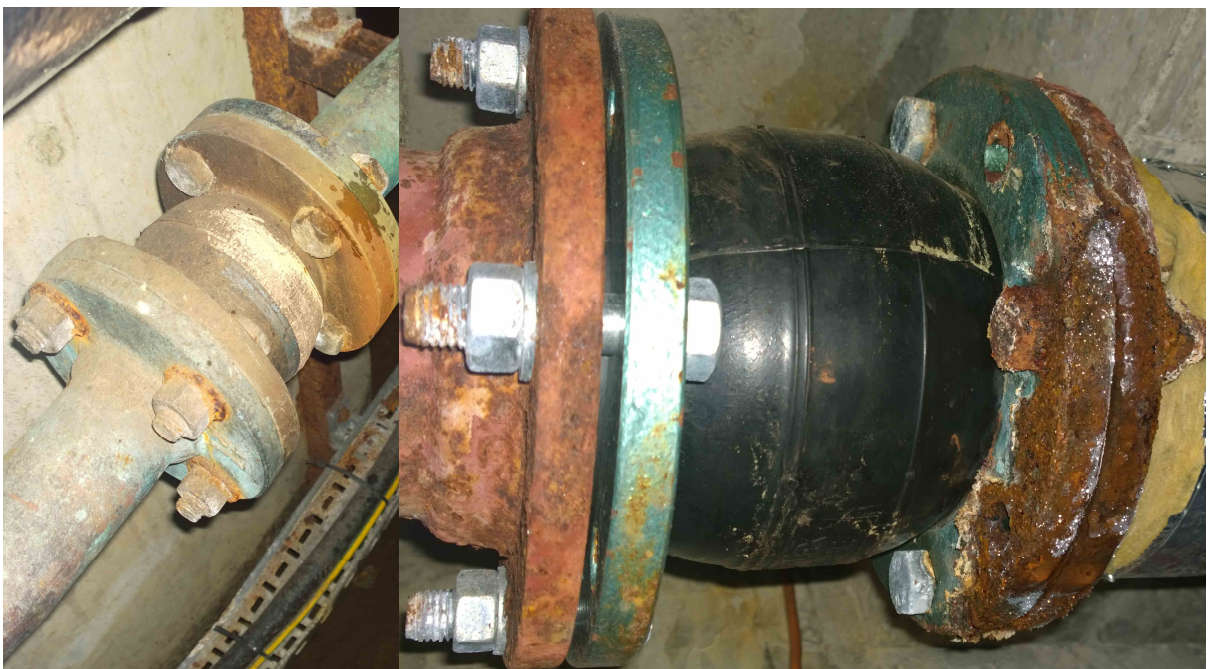
#### **Plantroom ZPL5 Duct**

As with the East West Duct these bellows are located in runs of pipe, not on pumps.

1 x 50mm Whiteband type Nitrile untied Table E, correctly installed, very hard and needs replacing. In a copper line and on Chilled Water.

1 x 100mm EPDM untied Table E, in-correctly installed due to misalignment and missing bolt holes, very hard and needs replacing. On a heating line.

All of the bellows are in a very poor condition and need either removing (if they are deemed surplus to requirements) or replacing as a matter of urgency.

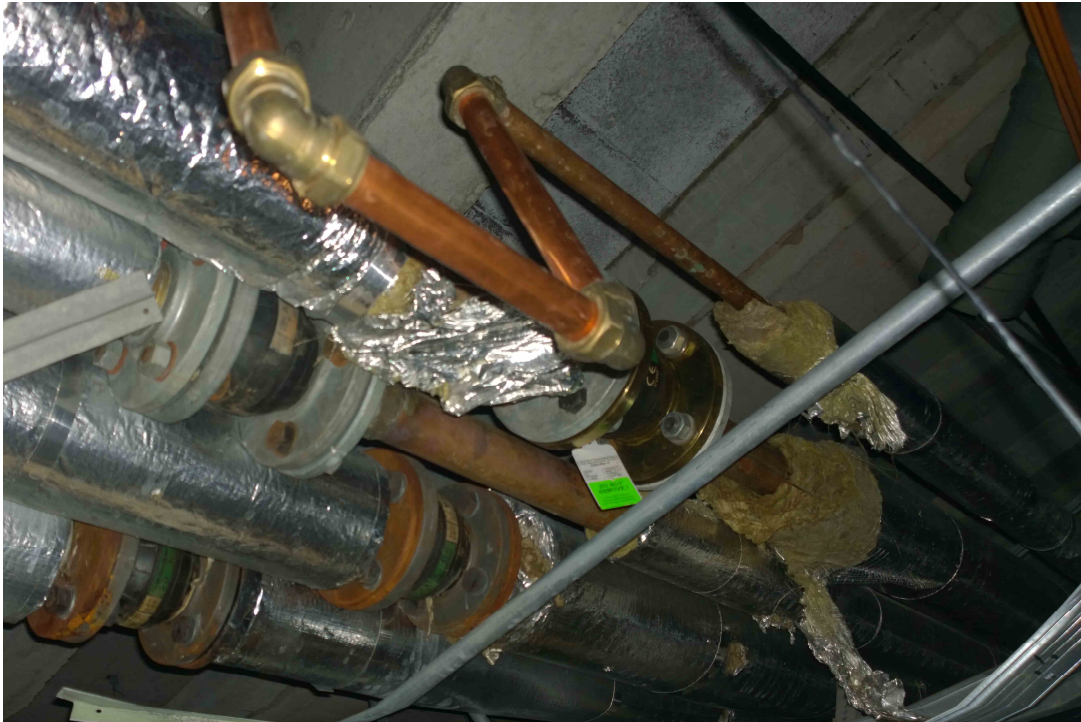
### **Kitchen Back Corridor Ceiling Void**

1 x 15mm Copper Standpipe Stainless Steel Axial Expansion Joint. On Domestic Hot Water. Has been removed at some point and replaced with an ineffectual expansion loop, also isn't anchored.

One of these has recently been replaced and looks to be in acceptable condition, although as with L2 East West Link Corridor Ceiling Void I would be concerned about the potential movement that these bellows are exposed to, as we are unsure about if and where they are anchored. The other 3 bellows in this position require replacing as they are showing signs of splitting and seepage.
